REPORT No. 862

## AN INVESTIGATION OF A THERMAL ICE-PRE- VENTION SYSTEM FOR A TWIN-ENGINE TRANSPORT AIRPLANE

By ALUN R. JONES

Ames Aeronautical Laboratory  
Moffett Field, Calif.

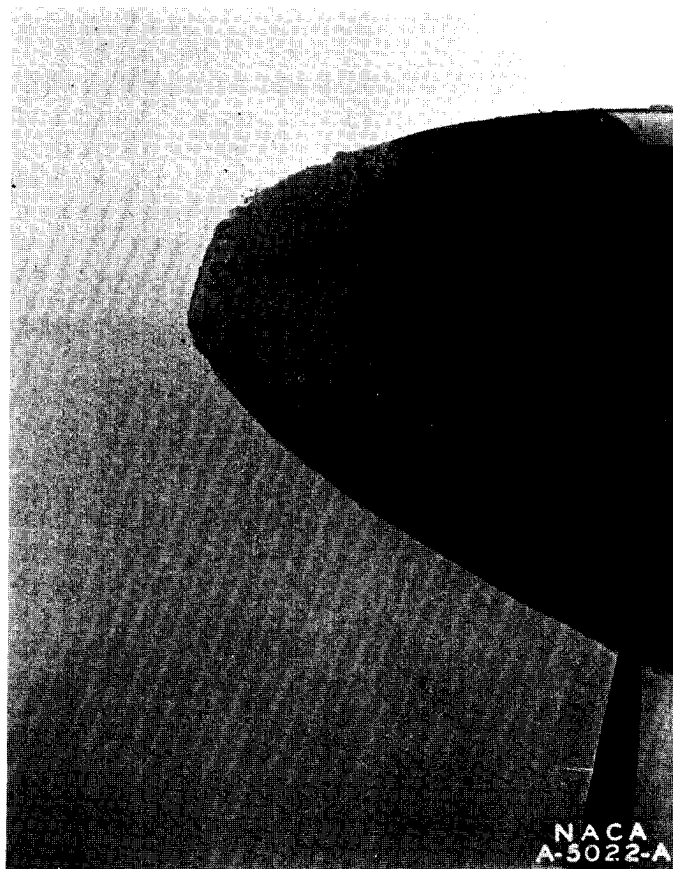
FIGURE 31.—Nose of test airplane after flight 50. Rearward extension of the accretion had fallen off.

icing conditions. Figures 31 and 32 are photographs taken after landing of some of the ice accumulations resulting from this flight. These ice formations were much larger in flight. The temperature of the ambient air before landing in Minneapolis was 38° F and the ice was melting and falling off at the time the pictures were taken. During flight, the ice on the cowling (fig. 32) had extended 2 to 3 feet rearward along the nacelle sides and the ice on the nose of the airplane (fig. 31) had extended rearward over the windshields.
